The site of the former **Hospital de la Santa Creu i Sant Pau** is located in Barcelona. Designed by the **architect Lluís Domènech i Montaner**, one of the **main representatives of Catalan modernism**. It was built between 1902 and 1930, in two phases.

In the year 2011 we began a process of rehabilitation of the **Administration Pavilion** due to the numerous pathologies that the building suffered.

In October 2011 we commissioned the company **Rehabilit** (partner in Catalonia of the company **Humicontrol**) to treat the **rising damp** that affected the **Administration Pavilion**.

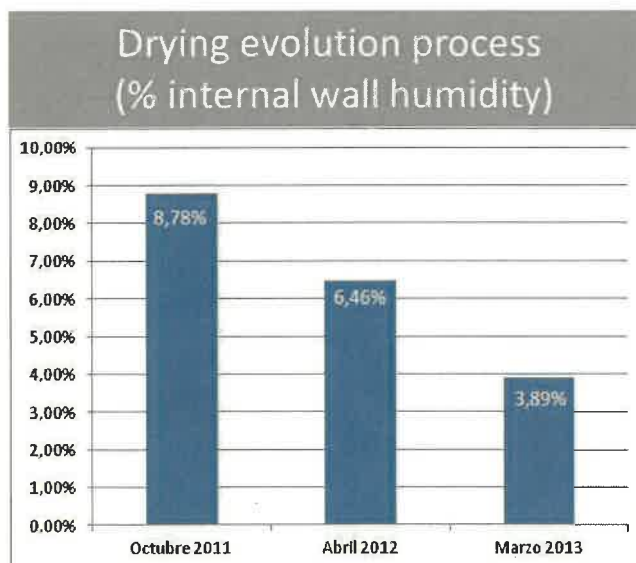
We repeated the same process in **April 2012** and finally in **March 2013** obtaining a result of **6.46%** and **3.89%** respectively.

The attached graph shows the evolution of the drying process of the walls until reaching the residual moisture value.

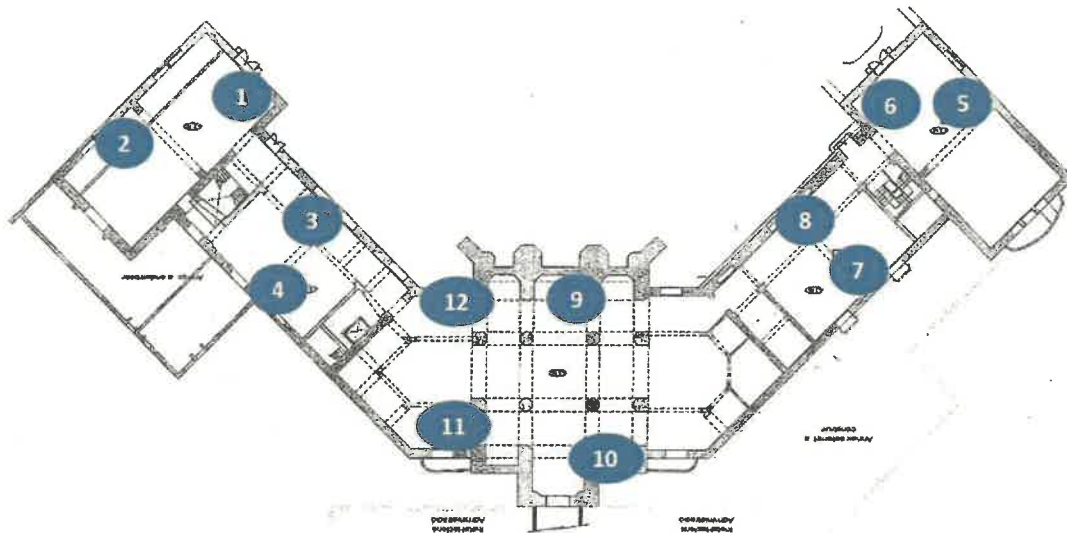
The attached floor plan shows the 12 locations where moisture samples were taken using the Calcium Carbide system.

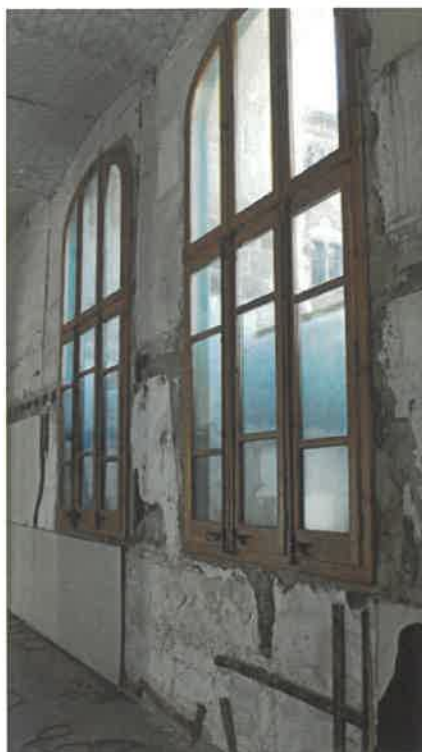
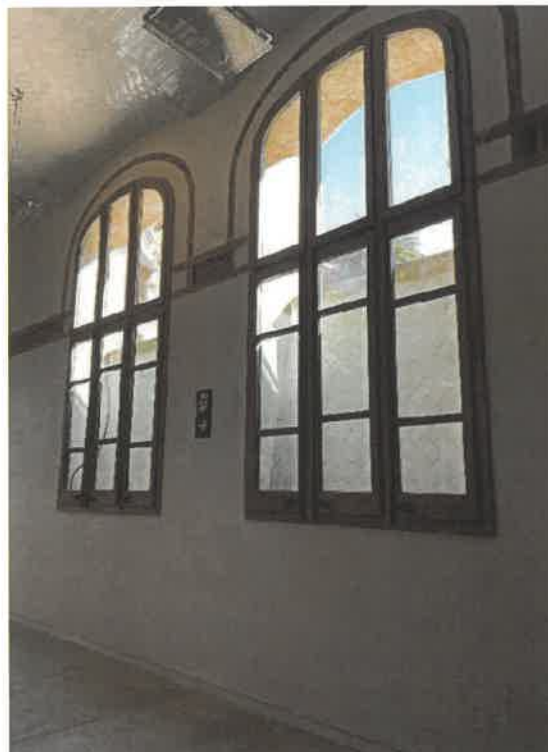
The surface of the ground floor of the building, approximately 1,650 m², **suffered from rising damp in a generalized way in all the walls of the ground floor**.

We attach a photograph of one of the walls in its initial state, and in its current state.

Once we verified the clear decrease in the humidity of the walls, we proceeded to restore the walls with the appropriate lime mortars.
