The site of the former **Hospital de la Santa Creu i Sant Pau** is located in Barcelona. Designed by the **architect Lluís Domènech i Montaner**, one of the **main representatives of Catalan modernism**. It was built between 1902 and 1930, in two phases.

In the year 2011 we began a process of rehabilitation of the **Administration Pavilion** due to the numerous pathologies that the building suffered.

In October 2011 we commissioned the company **Rehabilit** (partner in Catalonia of the company **Humicontrol**) to treat the **rising damp** that affected the **Administration Pavilion**.

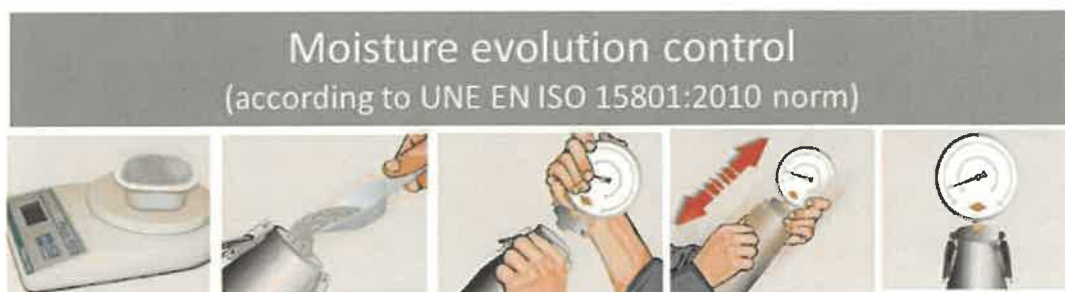
The correct way to measure the humidity of the wall is through the **Calcium Carbide system**. The system consists of making some holes in the wall in order to obtain a sample of the internal material of the wall. This material is deposited in the carbide pump, where the calcium carbide is also inserted. Calcium carbide reacts with moisture present in the sample and acetylene is produced. The pressure gauge of the carbide pump indicates the exact % humidity of the sample. This is the **only system accepted at the regulatory level to ensure the moisture value of a wall according to the UNE EN ISO 15801:2010 standard (Conservation of cultural heritage. Test methods. Determination of water absorption by capillarity.)**
